# ENGINEERING CONDITION SURVEY AND STRUCTURAL INVESTIGATION OF MONTGOMERY LOCKS AND DAM OHIO RIVER

March 1977

Final Report

Prepared for U. S. Army Engineer District, Pittsburgh  
Pittsburgh, Pa. 15222

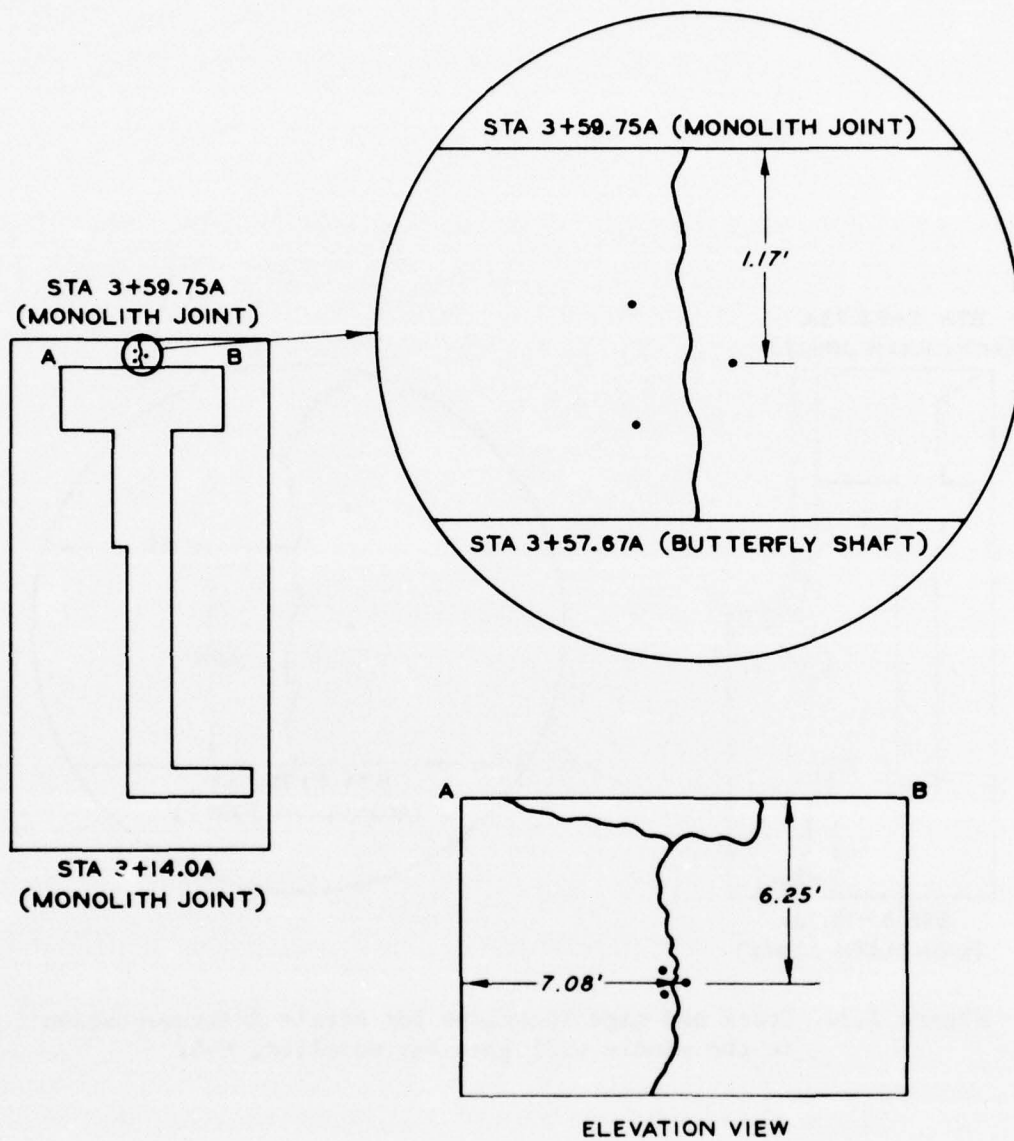
2.7 The crack in the upstream land wall butterfly-valve monolith was monitored from the top of the monolith and also from the vertical face within the butterfly-valve shaft. The other two cracks were monitored only from the top of the monolith.

2.8 The measurements determining crack movement under water, gate, and valve loadings were accomplished with a Dimic Gage having a 0.00001 in. accuracy. There was no detectable crack movement under any combination of loading. The relative movement across the cracks were monitored by the principles given in ETL 1110-2-118 except a more precise instrumentation was used which would detect movement of

Figure 2.2. Crack and gage locations for strain instrumentation in the land wall butterfly valve monolith, L-19.

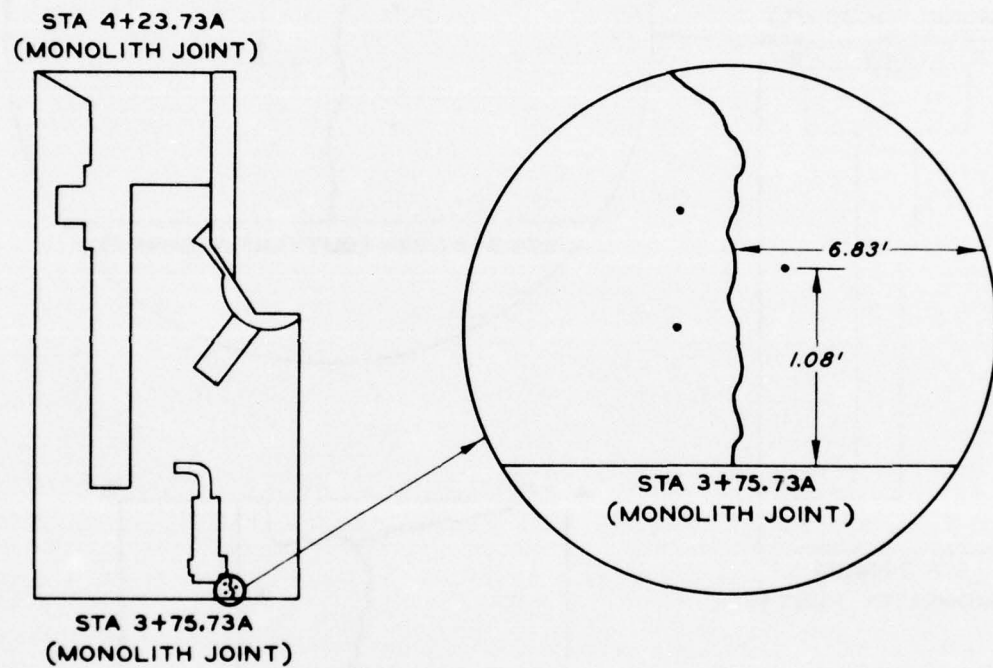
Figure 2.3. Crack and gage locations for strain instrumentation in the middle wall gate bay monolith, M-5.

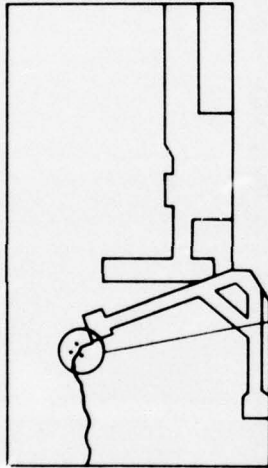
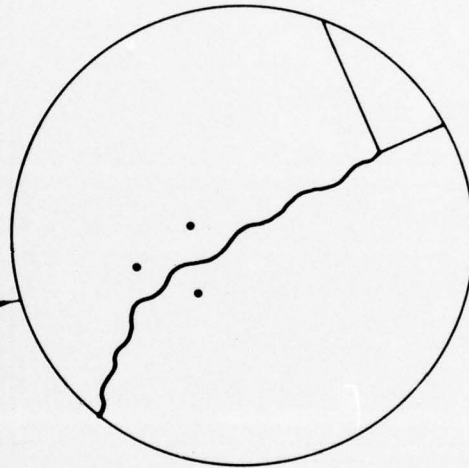
Figure 2.4. Crack and gage locations for strain instrumentation in the river wall gate bay monolith, R-12.

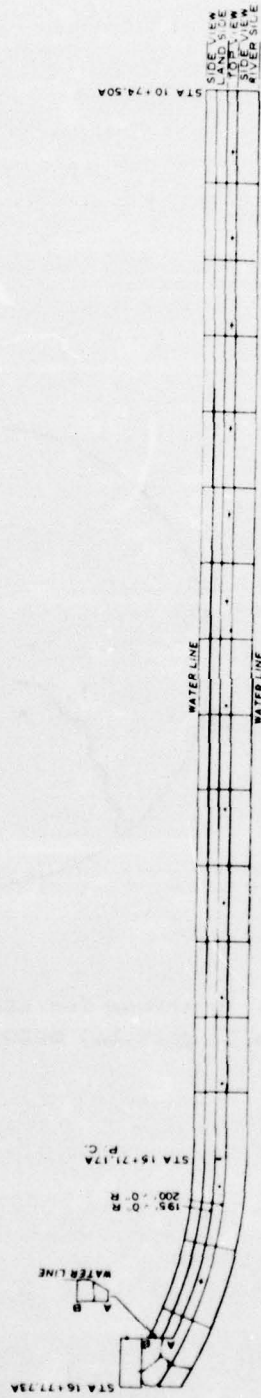
Figure 2.5. Crack survey, extension to upper guide wall,  
Montgomery Locks and Dam, Ohio River.

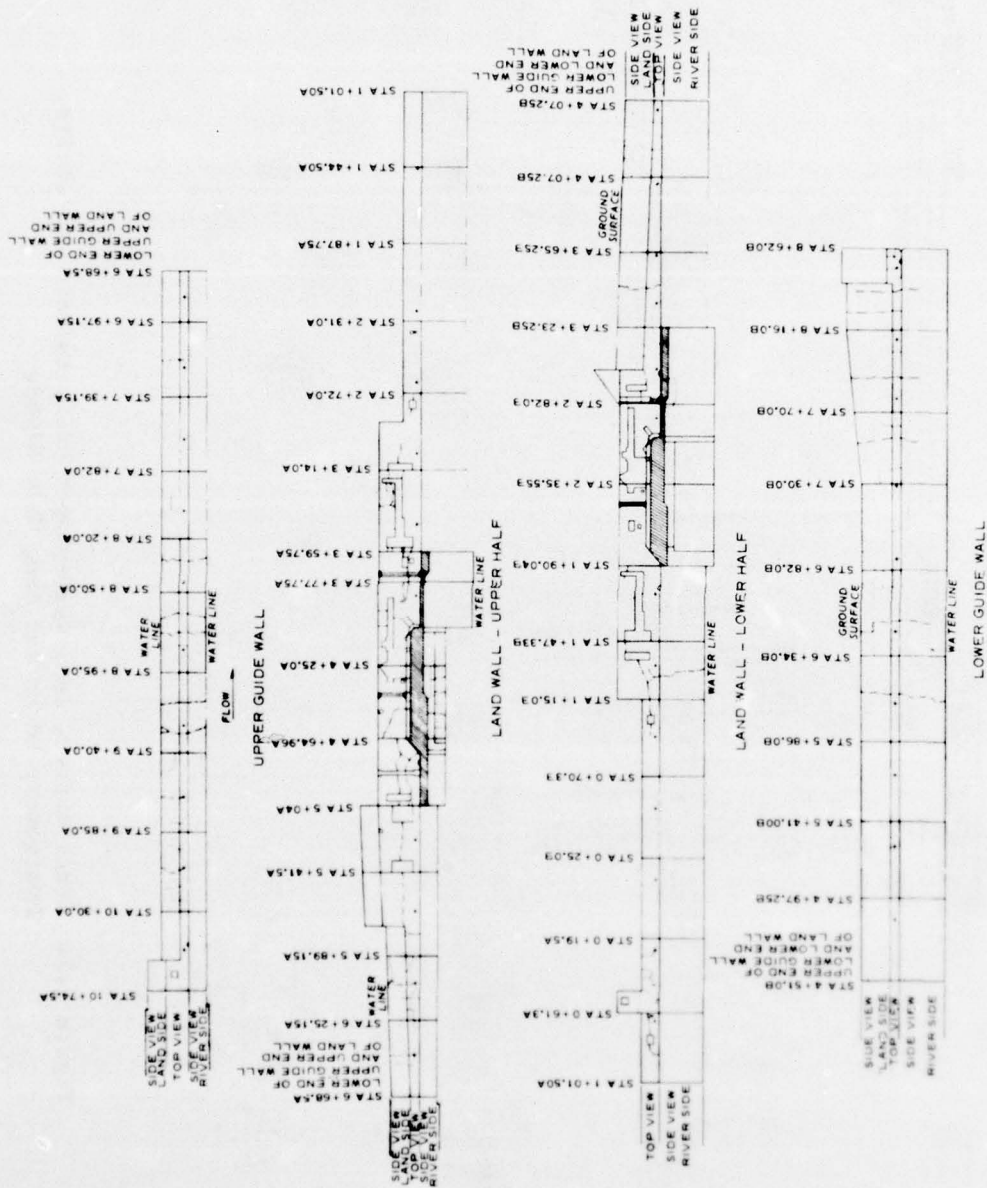
Figure 2.6. Crack survey, land and guide walls, Montgomery Locks and Dam, Ohio River.

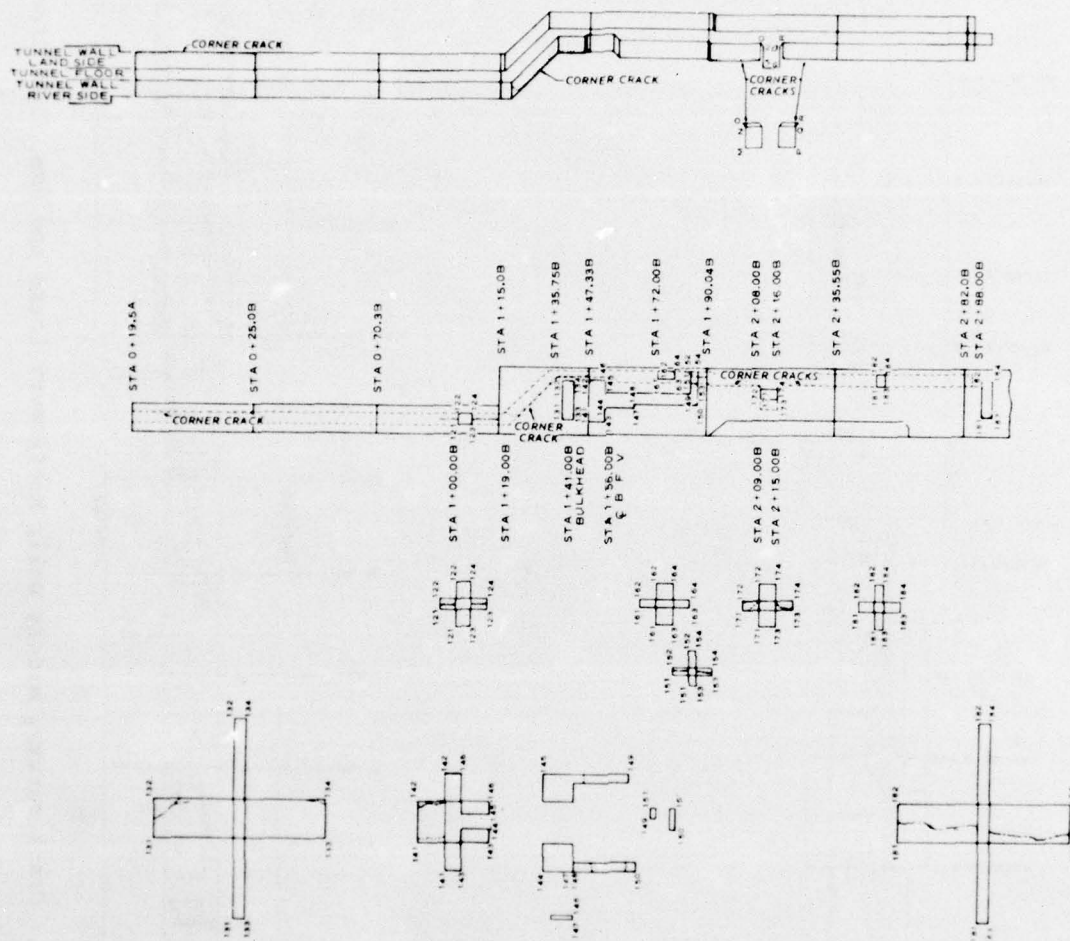
Figure 2.8. Crack survey, land wall--lower half, tunnels and shafts, Montgomery Locks and Dam, Ohio River.

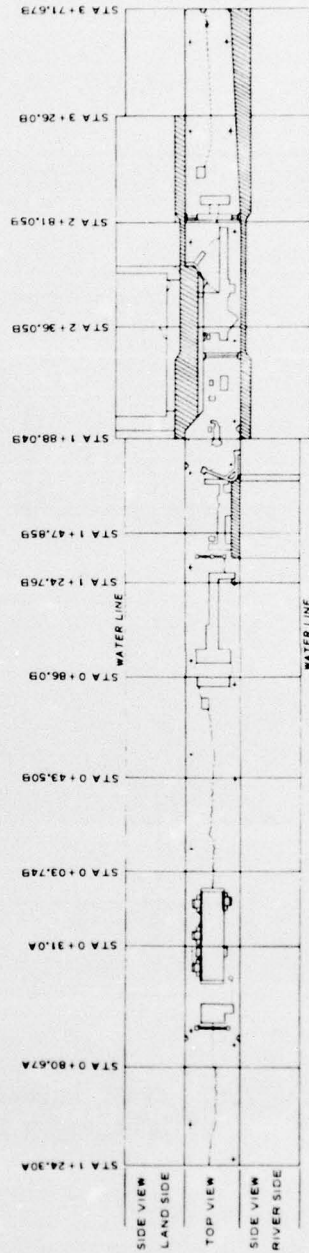
Figure 2.9. Crack survey, middle wall, Montgomery Locks and Dam, Ohio River.

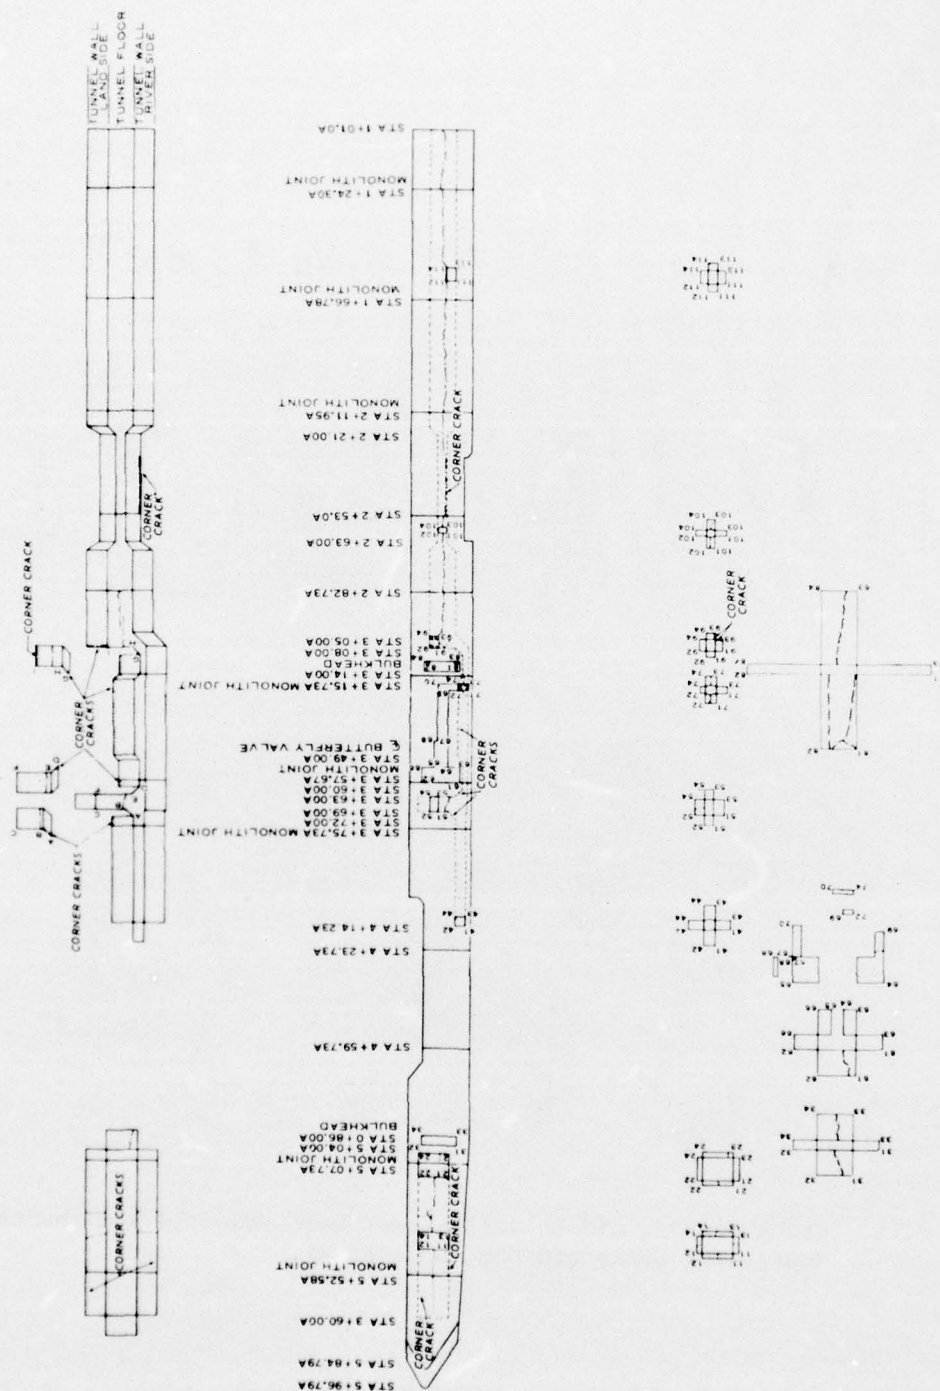
Figure 2.10. Crack survey, middle wall--upper half, tunnels and shafts, Montgomery Locks and Dam, Ohio River.

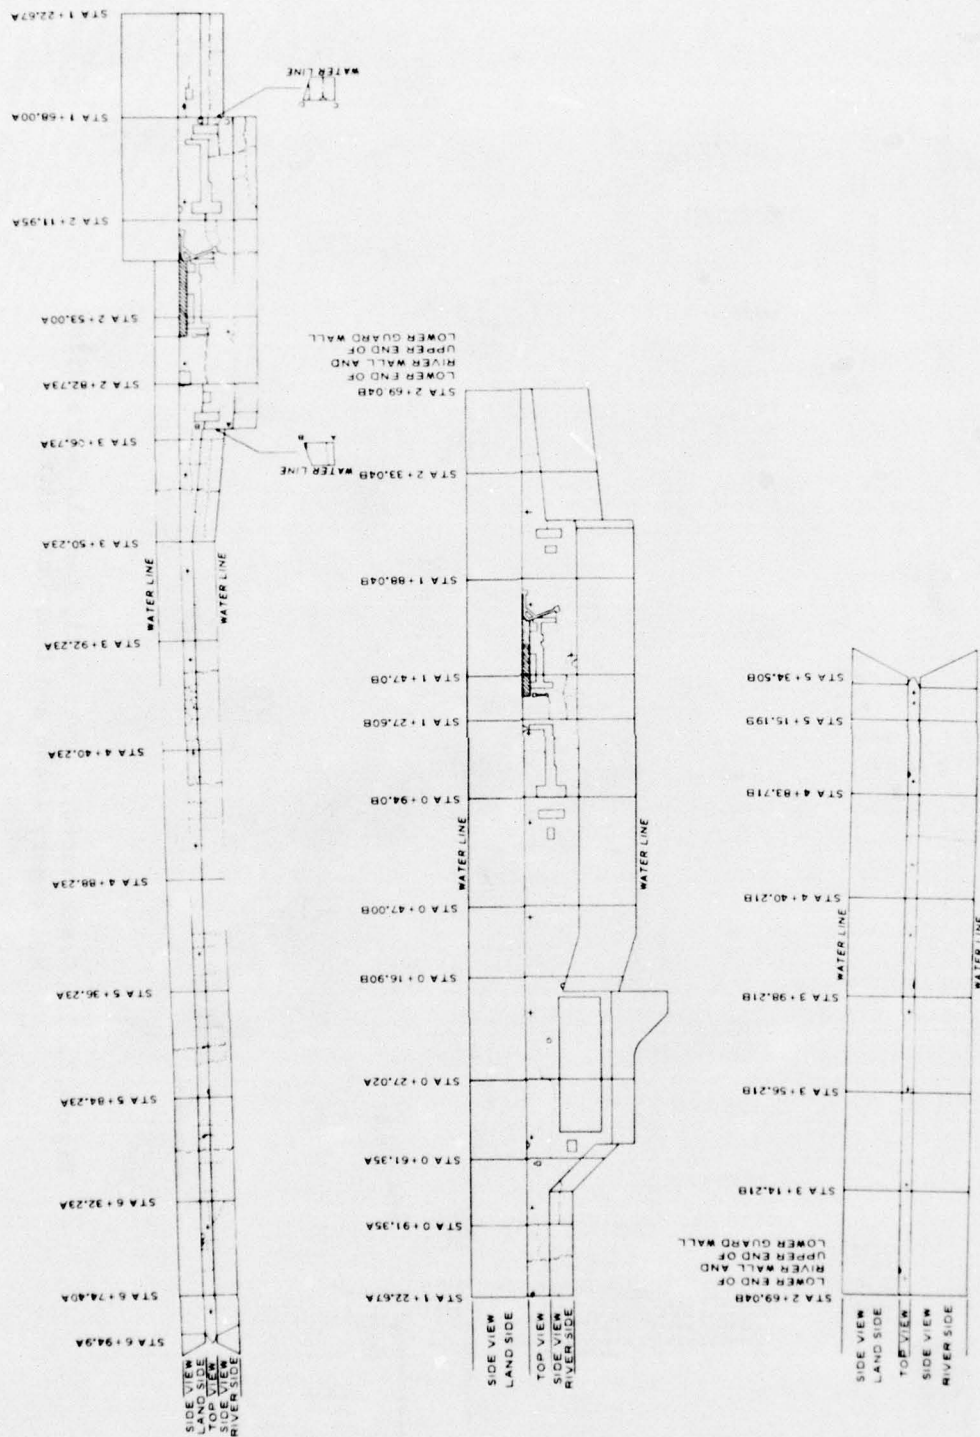
Figure 2.12. Crack survey, river and guard walls, Montgomery Locks and Dam, Ohio River.

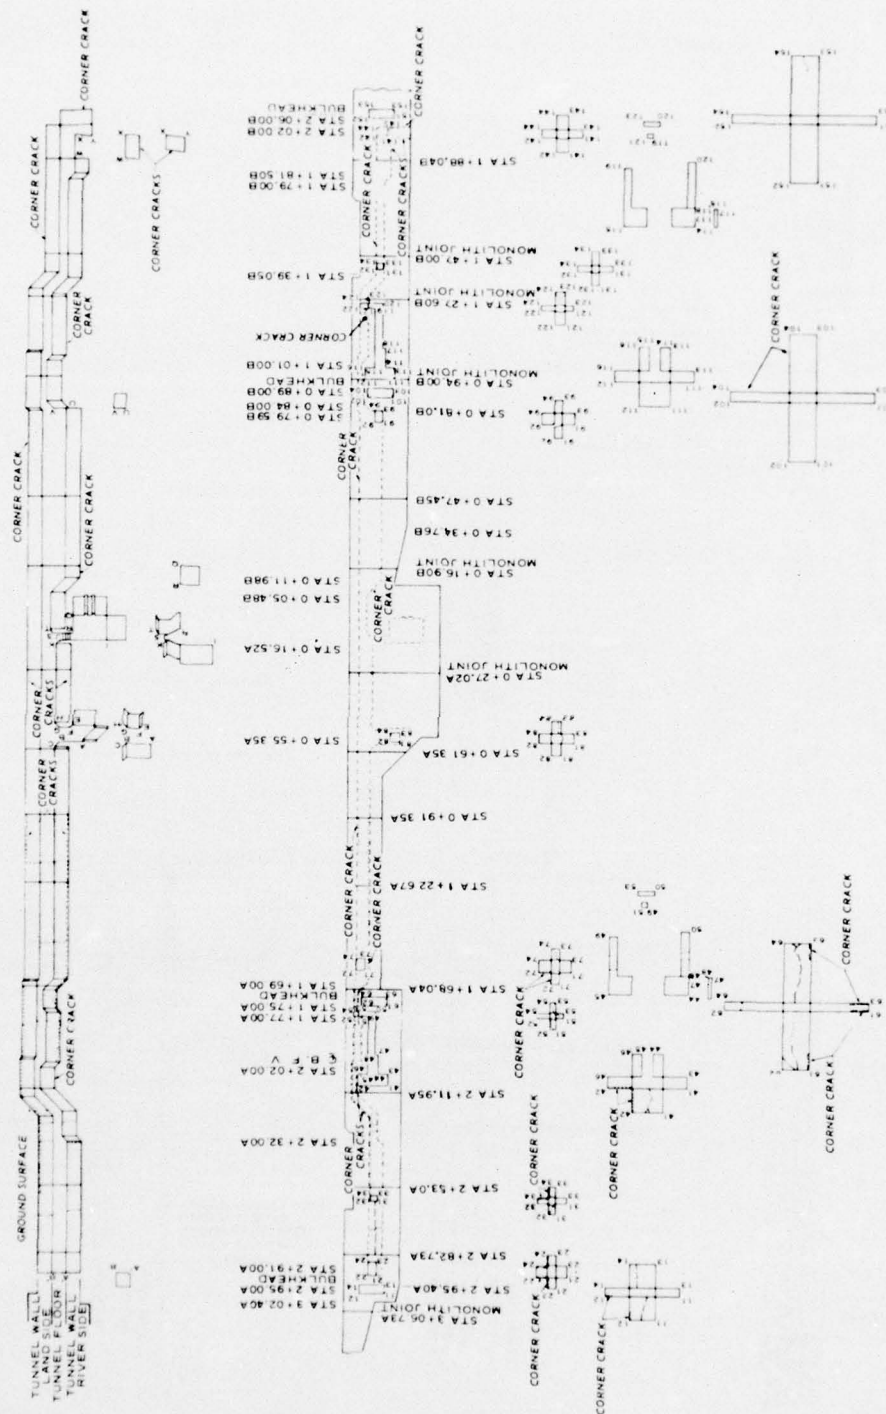
Figure 2.13. Crack survey, river wall, tunnels and shafts, Montgomery Locks and Dam, Ohio River.

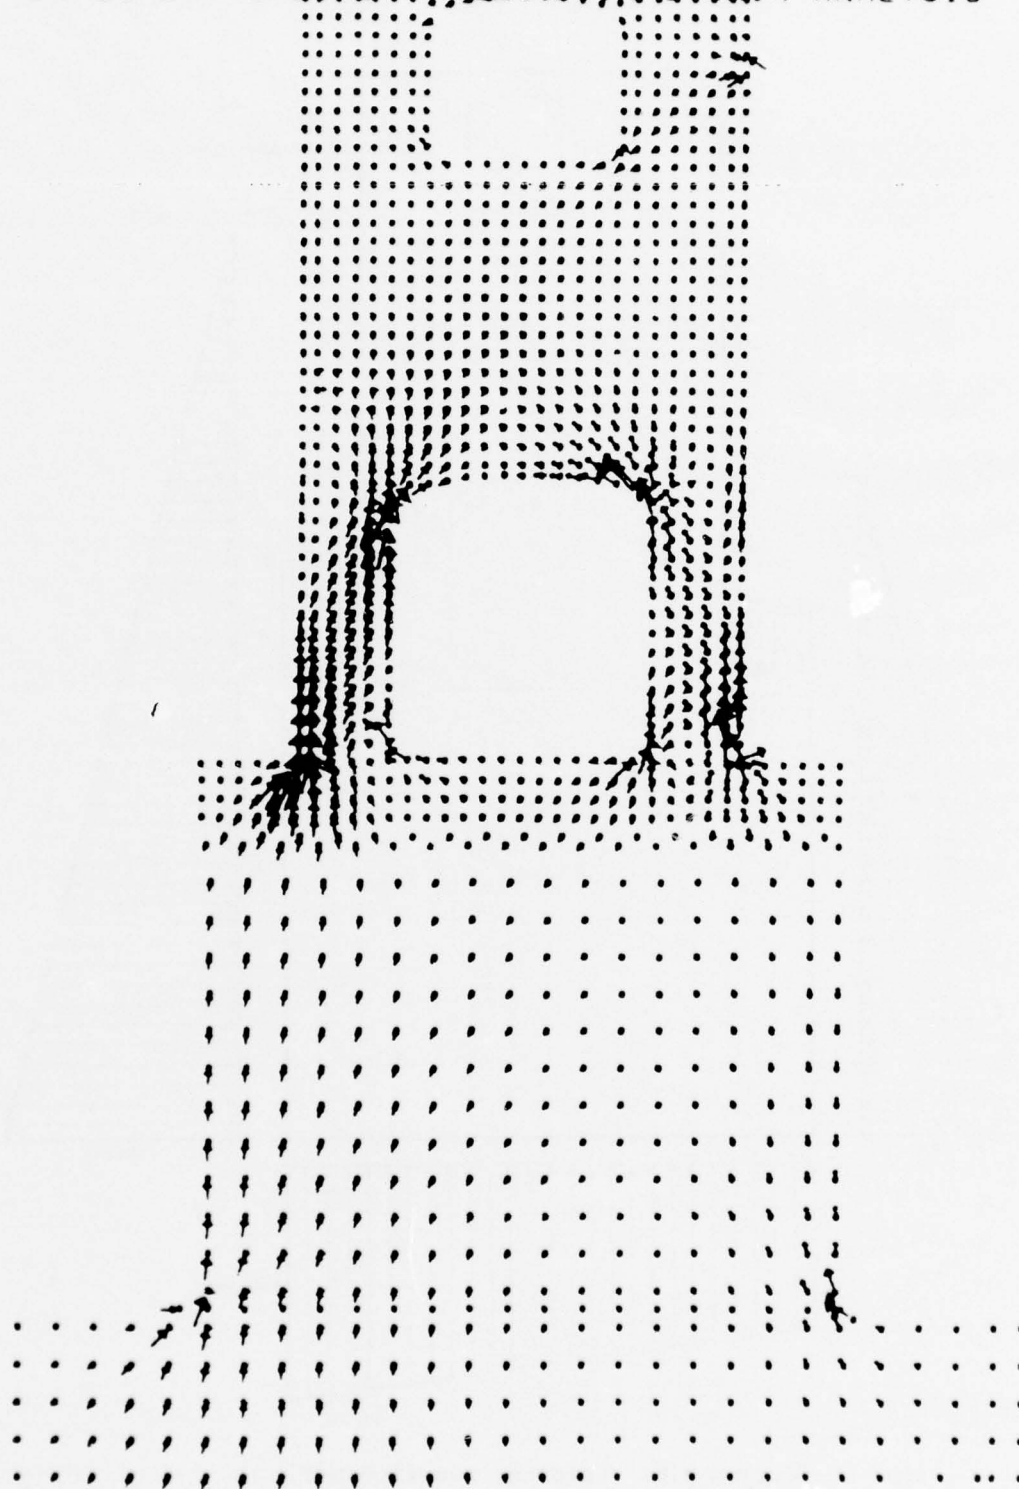
The stress in the culvert wall of monolith M-8 is greater than 800 psi tension. This tensile stress is too large and will crack the concrete. This allows a stress flow up through the center of the monoliths, thereby causing cracking. This hypothesized condition for cracking should be checked by inspecting the culvert walls as soon as possible.

Figure 6.9. Monolith M-8, total stress distribution, normal operating case.

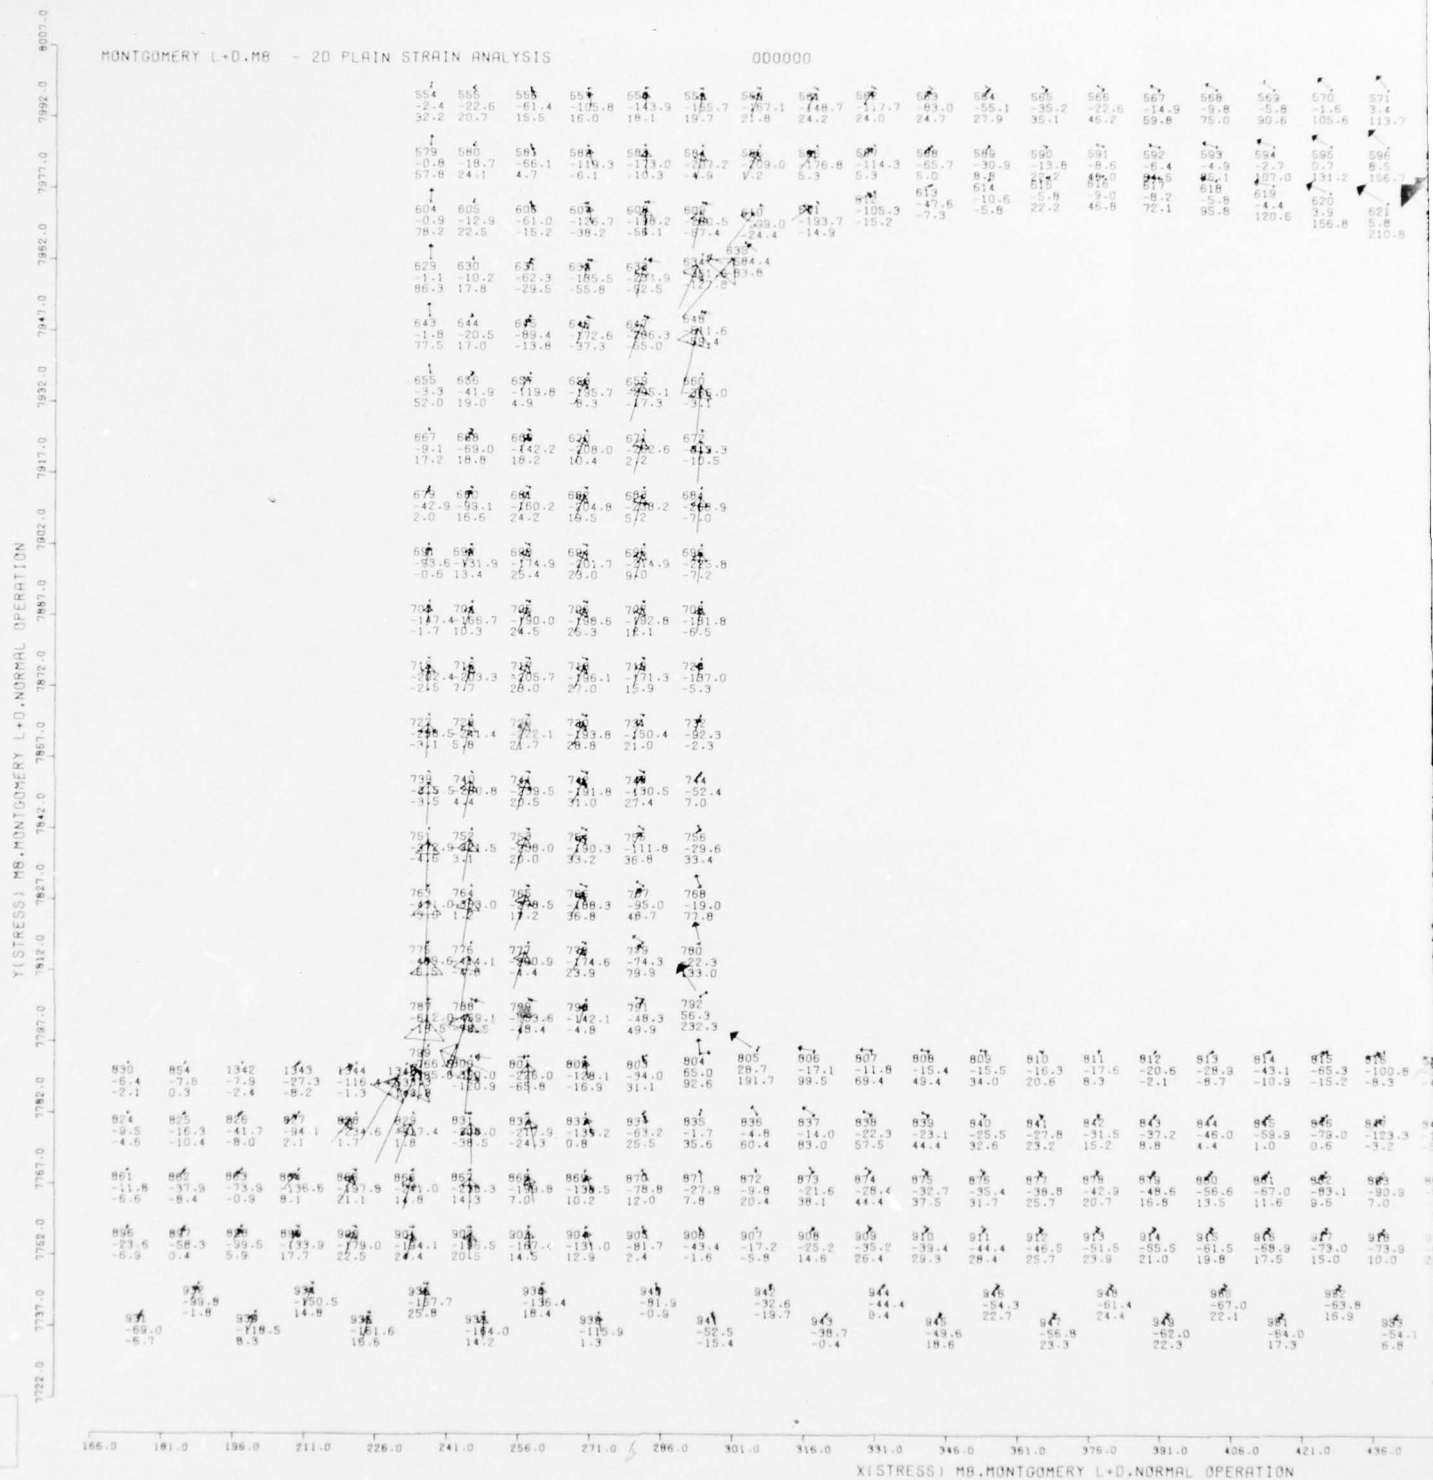
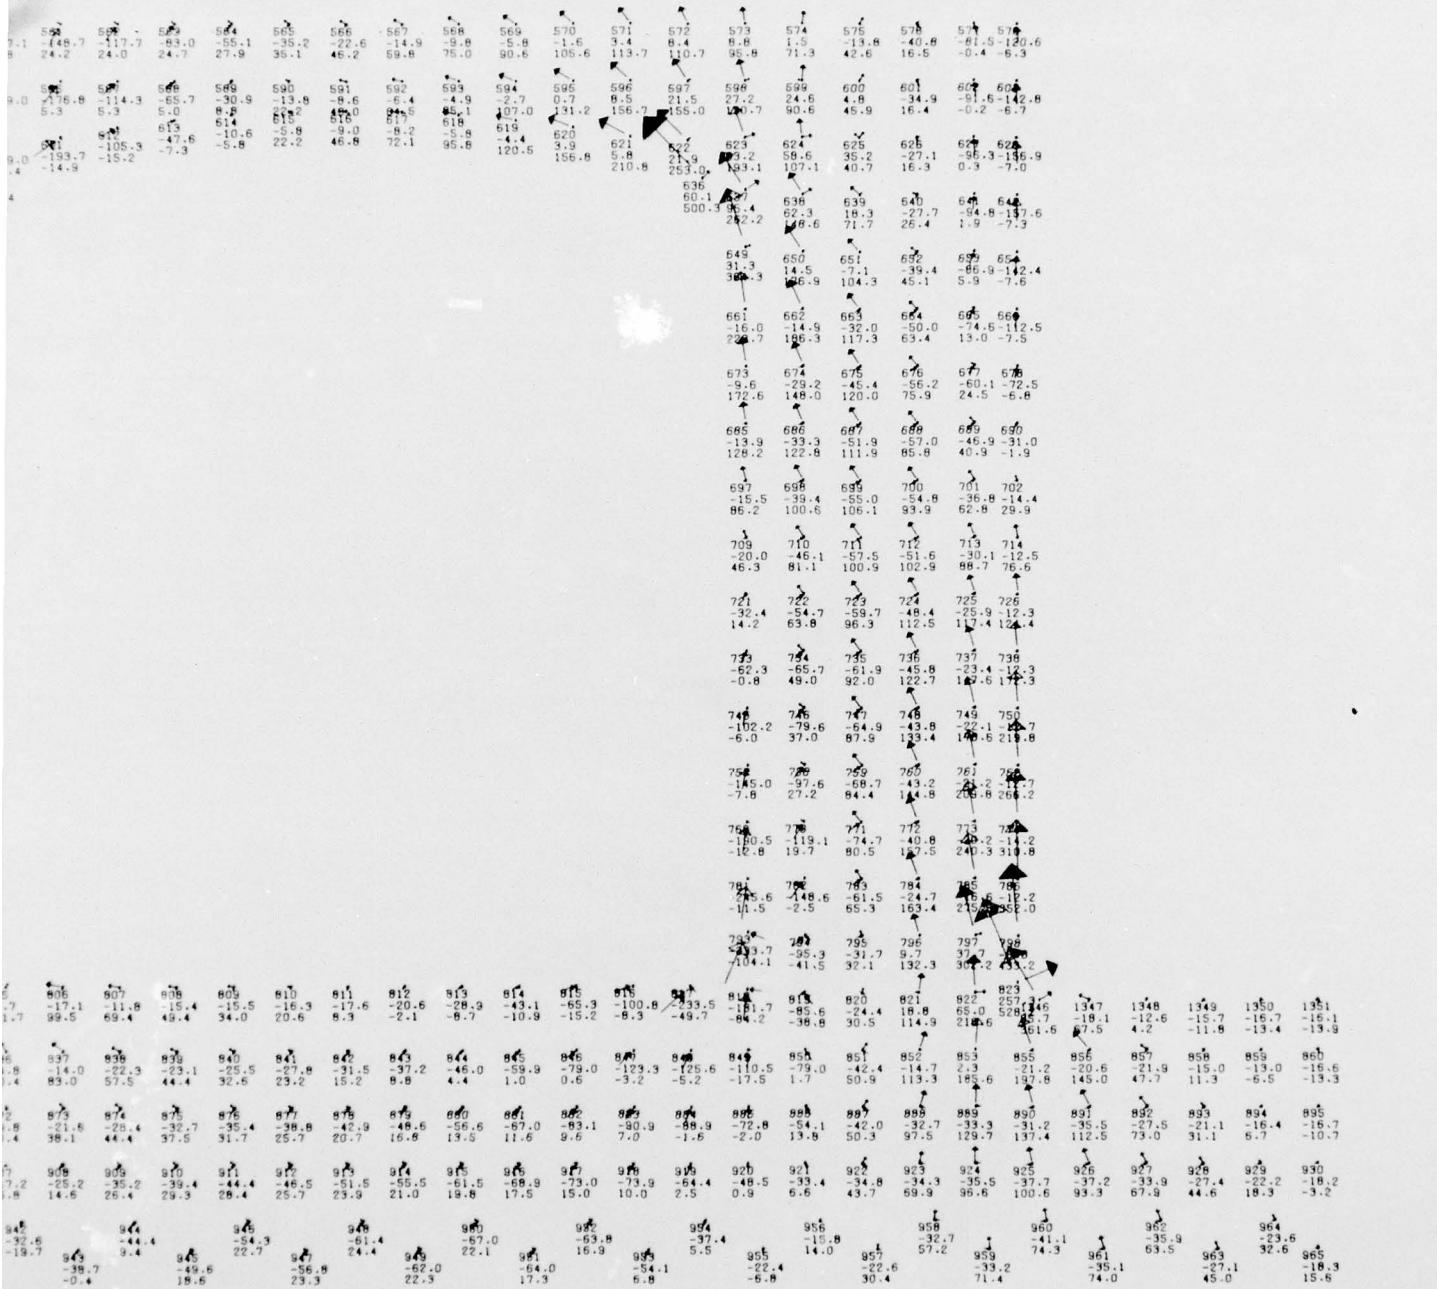
Figure 6.11. Monolith M-8, area of stress distribution as area "B."
